# Durability Assessment of ETICS: Comparative Evaluation of Different Insulating Materials

**Citation:** Landolfi, R.; Nicolella, M. Durability Assessment of ETICS: Comparative Evaluation of Different Insulating Materials. *Sustainability* **2022**, *14*, 980. <https://doi.org/10.3390/su14020980>

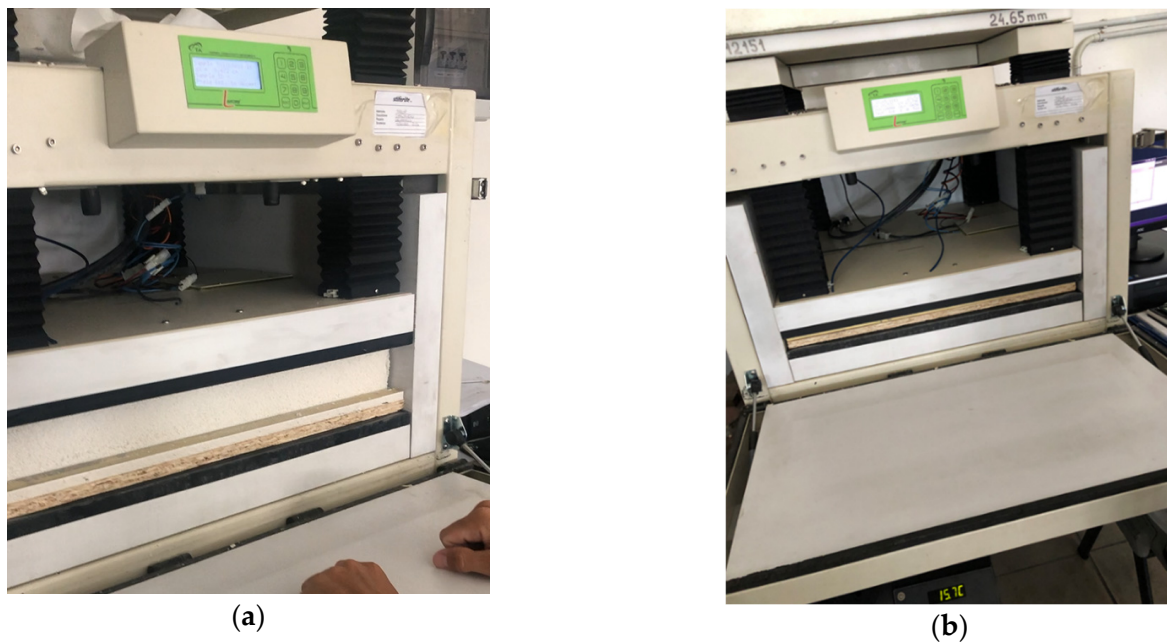
**Figure 2.** (a) Thermal resistance measurement according to EN 12667; (b) thermal resistance measurement of the stratigraphy needed to determine thermal resistance of each single material.

According to the EN 12667 [36], thermal resistance is determined by means of a guarded hot plate and a heat flow meter method. The whole sample is placed inside the standard equipment with flat and parallel sides as shown in Figure 2.

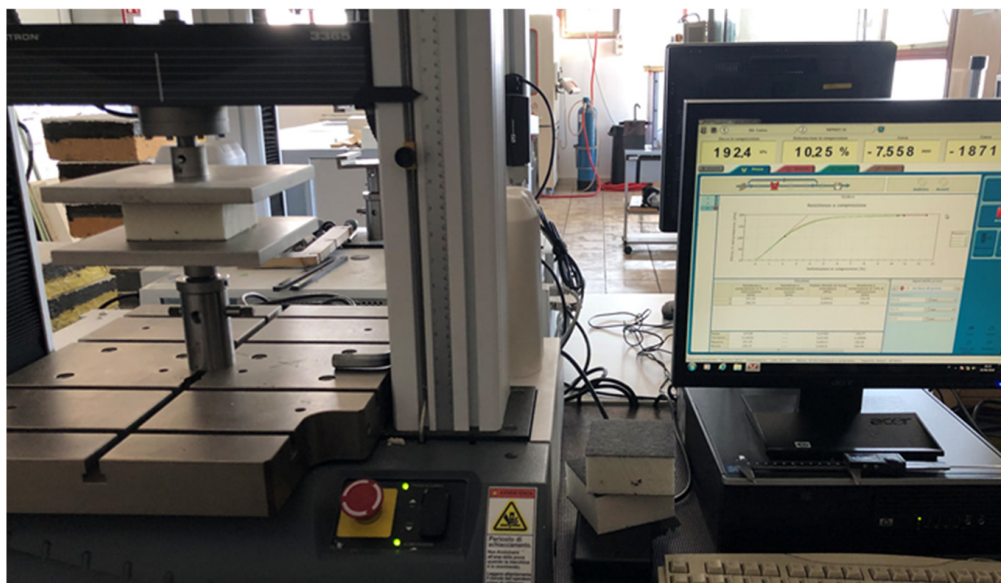
**Figure 5.** Compression test according to EN code 826; the machine apparatus is on the left and the report curve is on the right.

Compressive strength is determined according to UNI EN code 826 [41]. Five square test specimens, sized  $100 \times 100$  mm, obtained from each ETICS sample, are submitted to an applied compressive force in an axial direction. The forces, corresponding to 2% and 10% relative deformation, respectively, are reported. Figure 5 shows the test machine carrying out a compressive strength test, whereas on the right the PC screen shows the output of the test, which consists of a stress–strain diagram.

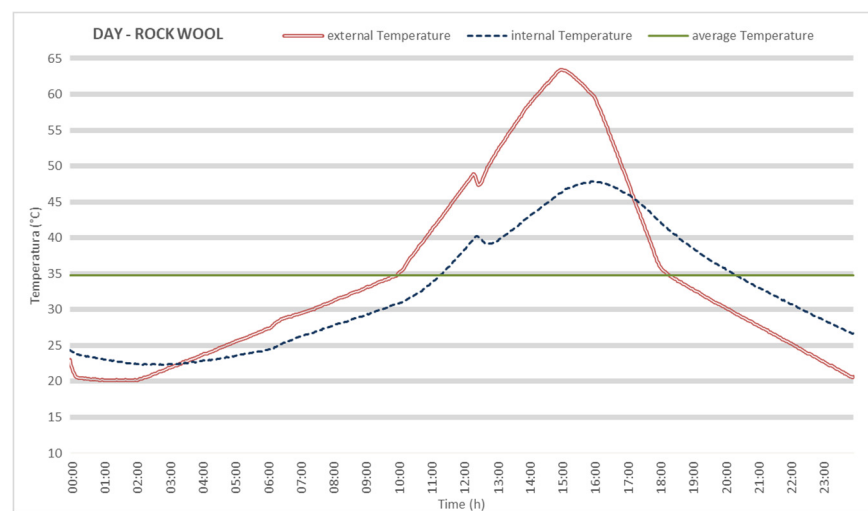
**Figure 6.** Sine waves reproducing the external surface temperature on the ETICS (red line) with MW as thermal insulating material, the internal surface temperature on the ETICS (blue line), and the average external temperature (green line) on the hottest day of the year.

Through these sine wave curves, it was possible to calculate the time shift and decrement factor based on Equations (2) and (3). Table 6 collects all recorded results in the first performance measurements, the time zero measurements determined before accelerated ageing tests.

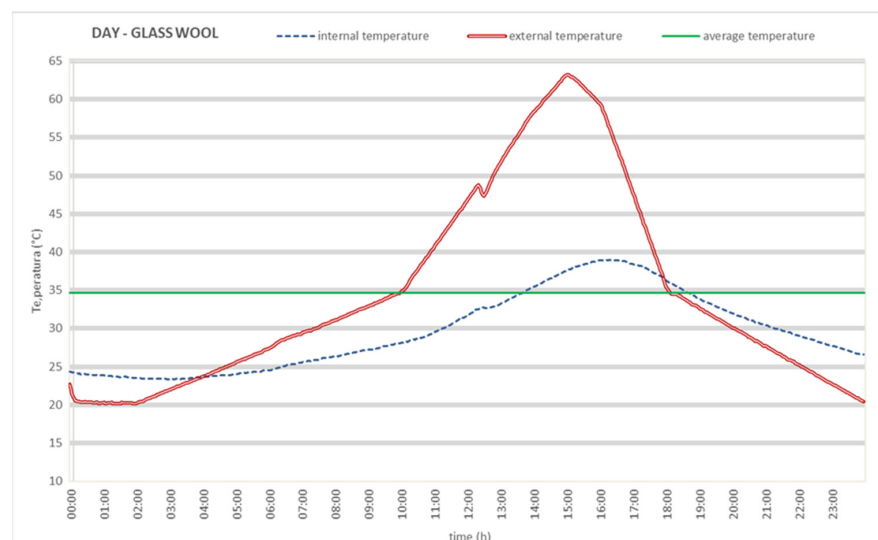
**Figure 7.** Sine waves reproducing: the external surface temperature on the ETICS (red line) with GW as the thermal insulating material, the internal surface temperature on the ETICS (blue line), and the average external temperature (green line) on the hottest day of the year.

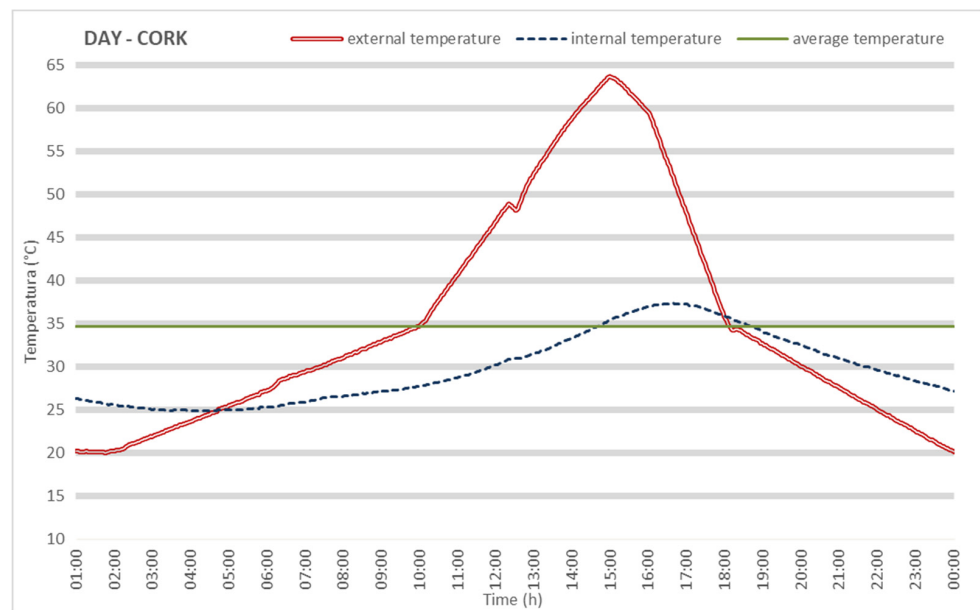
**Figure 8.** Sine waves reproducing the external surface temperature on the ETICS (red line) with ICB as the thermal insulating material, the internal surface temperature on the ETICS (blue line), and the average external temperature (green line) on the hottest day of the year.
